Maintain a copy of this form and any documentation provided with the insurance policy

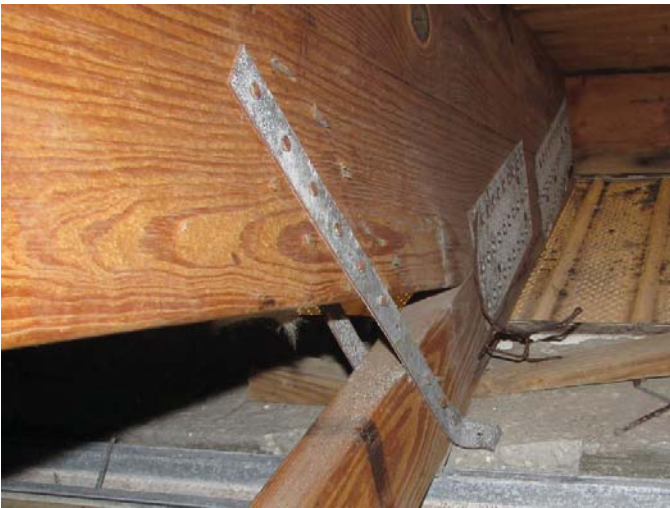
4. **Roof to Wall Attachment:** What is the **WEAKEST** roof to wall connection? (Do not include attachment of hip/valley jacks within 5 feet of the inside or outside corner of the roof in determination of WEAKEST type)
