Uniform Mitigation Verification Inspection Form

Inspection Date: 05/28/2015		
Owner Information		
Owner Name: Harbor Isles COA of Brevard, Inc.		Contact Person:
Address: 640 S Brevard Ave		Home Phone:
City: Cocoa Beach	Zip: 32931	Work Phone:
County: Brevard		Cell Phone:
Insurance Company:		Policy #:
Year of Home: 1999	# of Stories: 3	Email:

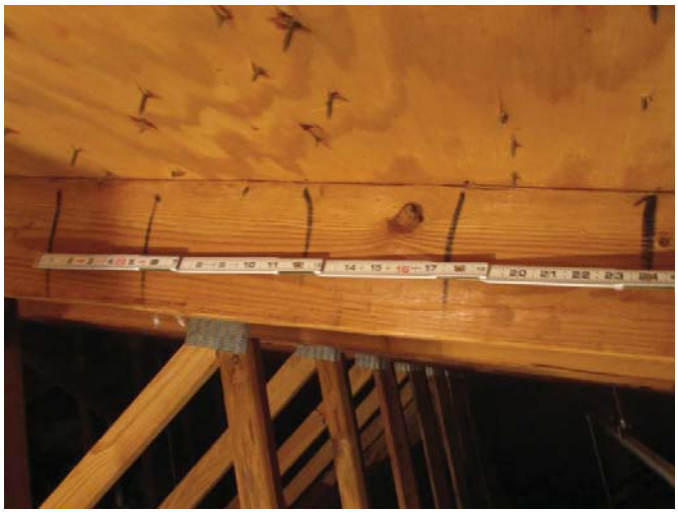
Nail Spacing

8d Nail

Single wrap

Single wrap (other side)

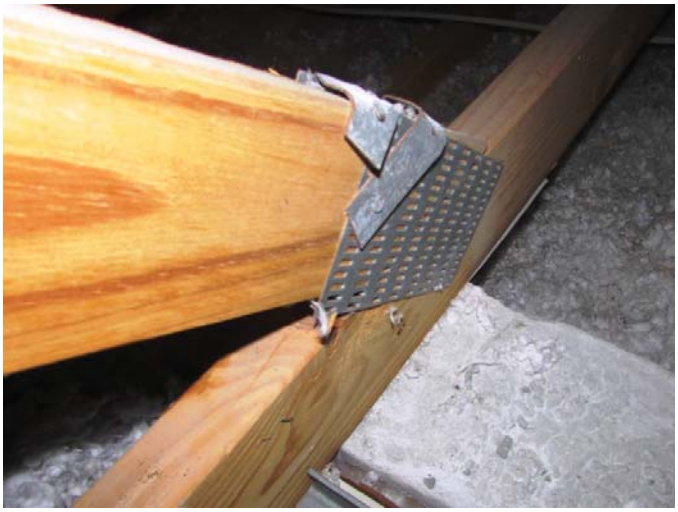
Single wrap (other side)
