Uniform Mitigation Verification Inspection Form

Inspection Date: 05/28/2015		
Owner Information		
Owner Name: Harbor Isles COA of Brevard, Inc.		Contact Person:
Address: 650 S Brevard Ave		Home Phone:
City: Cocoa Beach	Zip: 32931	Work Phone:
County: Brevard		Cell Phone:
Insurance Company:		Policy #:
Year of Home: 1999	# of Stories: 3	Email:

Inspectors Initials **Property Address** 650 S Brevard Ave Cocoa Beach

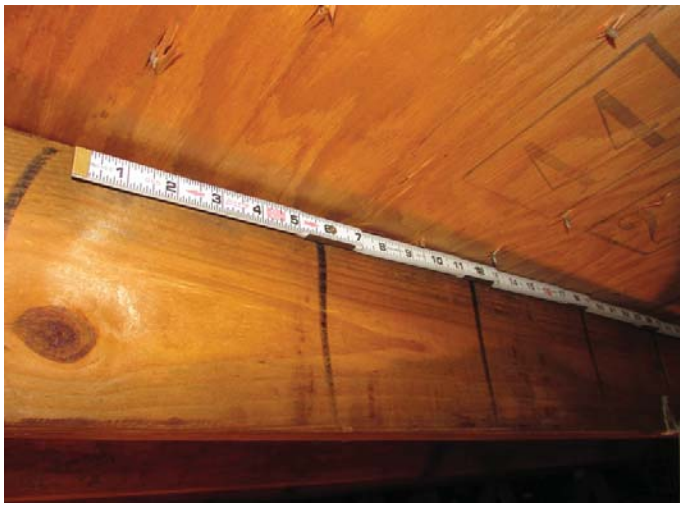
Plywood

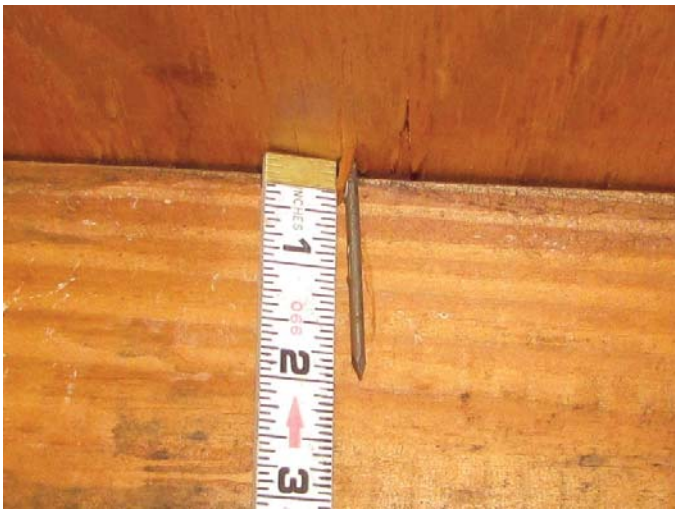
Nail Spacing

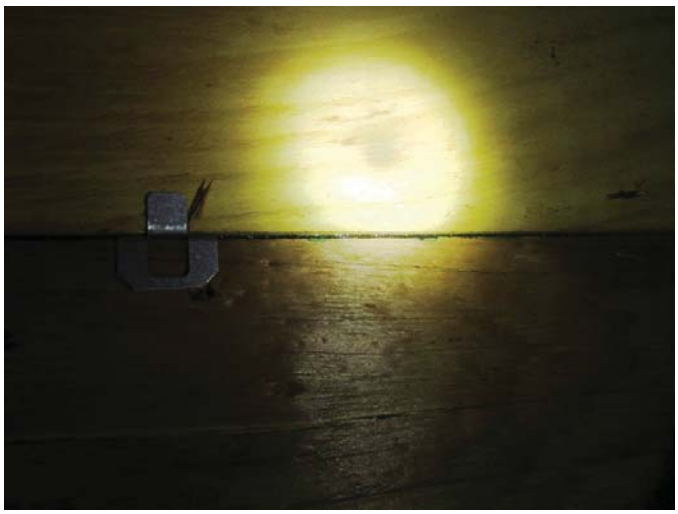
Secondary Water Resistance (SWR)
